Technical Bulletin

RP5-GM52-HAR
No Reverse Camera Image

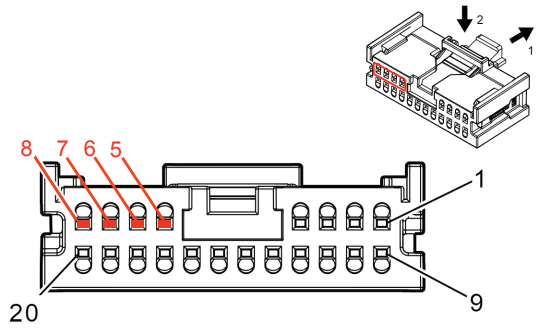
Fig.1

Gray 20 Pin Radio Display
Connector Viewed From Pin Side

Pin 5 - Camera + from Camera
Pin 6 - Camera - from Camera

Pin 7 - Camera + to RP5-GM52-HAR
Pin 8 - Camera - to RP5-GM52-HAR

1. Locate pins 5, 6, 7 and 8 at the Gray 20 pin harness on the back of the radio display (see Fig.1).
2. Cut the wires going to pins 5, 6, 7 and 8, near the connector, but leave enough length so that the wires can be reconnected if the factory radio is reinstalled.
3. The loose cut wires coming from the connector will not be used. The loose cut wires that continue into the harness will need to be connected as follows (see Fig.2):

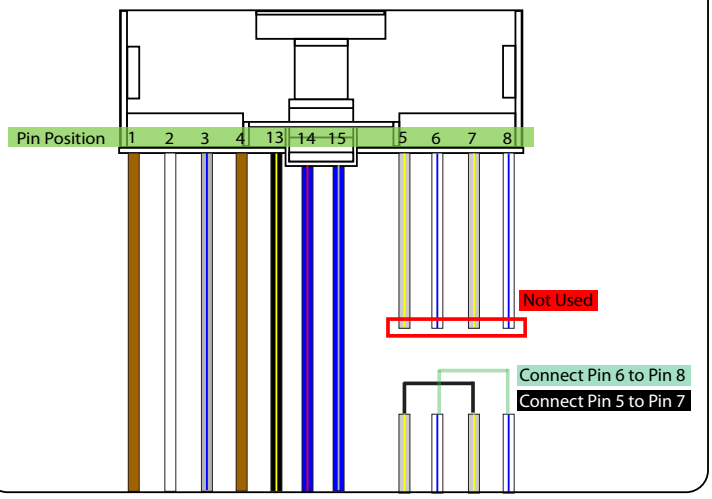
Fig.2

Gray 20 Pin Radio Display
Connector Viewed From Top

Connect Pin 5 to Pin 7.
   Connect Pin 6 to Pin 8.
4. Connect the Reverse Camera output connector from the RP5-GM52-HAR to the Reverse Camera input on the aftermarket radio.
